Pre-Purchase Inspection Report

Audi Tt
Verified by

**Date**
2025-03-19
-

**VIN Number**
XXXXXXXXXXXXXXXXXXXX

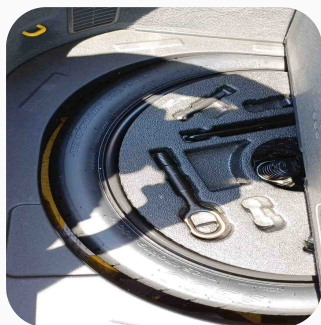
⚠ Spare tyre (ST)

Dry cracks

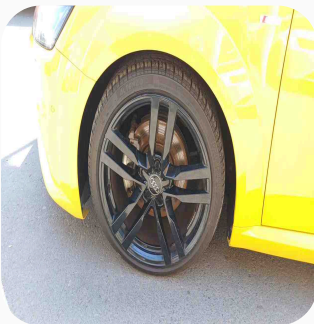
⚠ Rear Left (RL)

Surface Damage

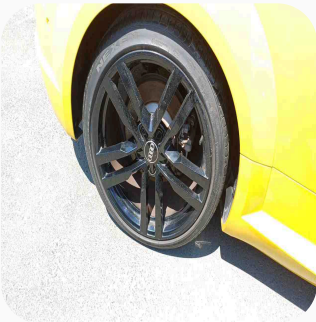
⚠ Front Left (FL)

Surface Damage

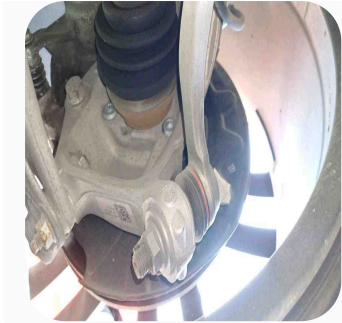
✓ Front Right (FR)

⚠ DISC

Need skimming

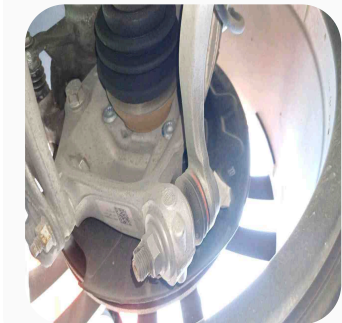
✔ Front Left (FL)

⚠ **DISC**

Need skimming

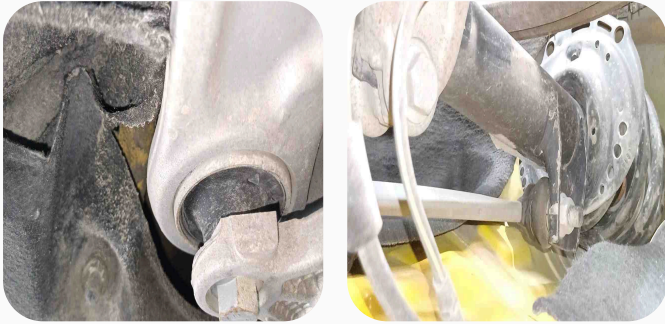
⚠ Front Suspension

Lower arm bush minor crack / major cracked- The lower arm bush shows signs of wear, ranging from minor cracks to major damage, caused by age, stress, or environmental factors. This can affect suspension stability, increase vibrations, and lead to uneven tire wear. Timely replacement is recommended to maintain safety and performance. Labor cost: Medium to High

Link rod boot damage- The link rod boot damage indicates wear or tearing, often caused by age, stress, or exposure to harsh conditions. This can lead to grease leakage, increased joint wear, and compromised suspension stability. Prompt replacement is recommended to maintain safety and optimal performance.

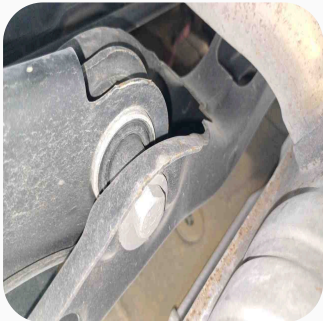
⚠ Rear Suspension

Control arm bush minor/major damage- The control arm bush shows signs of damage, ranging from minor to major severity, caused by age, stress, or harsh driving conditions. This can compromise suspension stability, increase vibrations, and lead to uneven tire wear. Timely inspection and replacement are recommended to ensure safety and optimal performance

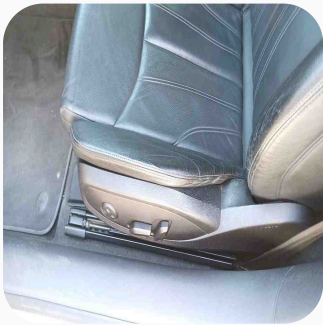
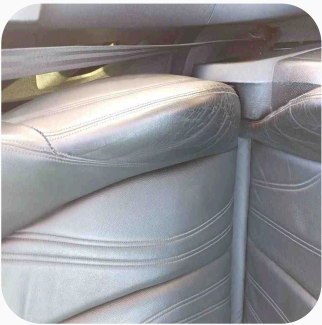
⚠ (Seats Upholstery)

Buttons wear and tear

Wear and tear on driver seat.

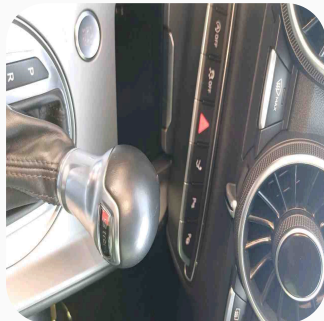
⚠ (Gear Lever)

Scratches

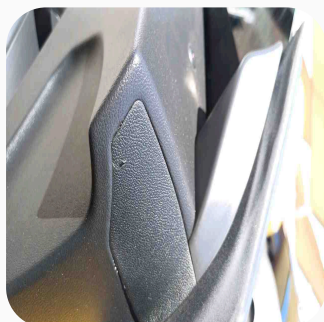
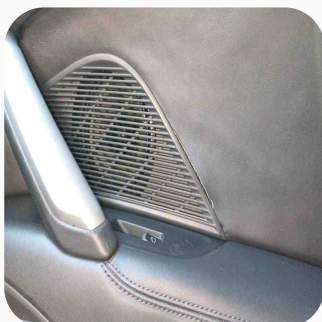
⚠ (Doors)

Damage

scratches

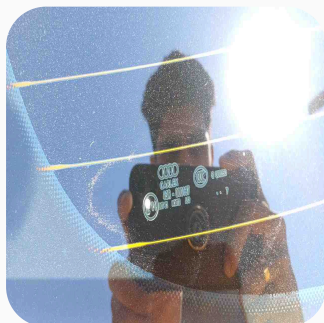
⚠ (Rear Windscreen)

Replaced

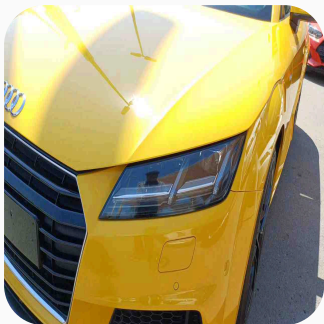
⚠️ Headlights

Not working

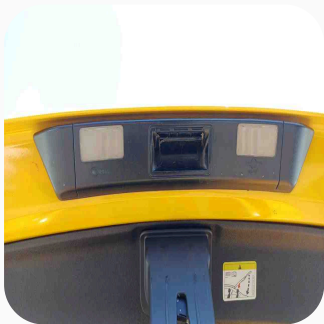
⚠️ Number Plate Lights

Not working

Cosmetic paint found on vehicle body. Silicone stains found on front bumper & head lights. Oil leak detected from multiple places. Suspension faults detected. Number plate light defective warning light showing on instrument cluster. Dirt & water scaling found on engine Bay and Undercarriage. Several error codes were found in diagnosis reports.

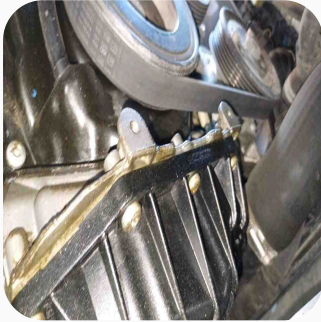
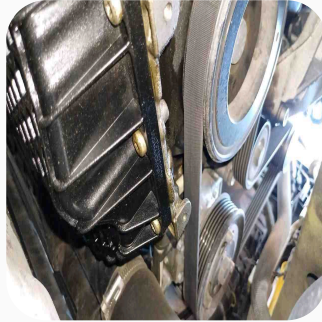
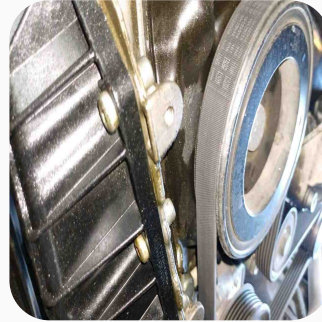
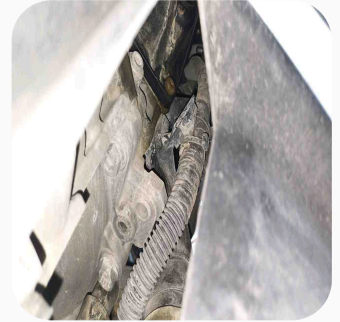
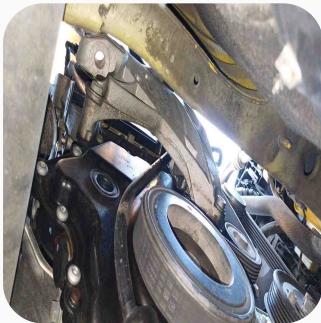
⚠ Engine Oil Leaks

Leak from oil pan gasket - The oil pan is a reservoir at the bottom of the engine that collects and stores engine oil, which has a leak. This means the seal between the oil pan and the engine is damaged or worn out, causing oil to leak out. Long term oil pan leaks can be dangerous for engine life span. Labor cost: Medium

Leak from crankshaft seal- A leak from the crankshaft seal means that the seal around the crankshaft, which prevents oil from leaking out of the engine, is worn or damaged. Long term oil leaks can be dangerous for engine life span. Labor cost: High

Leak from timing cover gasket - A leak from the timing cover indicates that the seal around the cover protecting the timing belt or chain is failing, leading to oil leakage. Long term oil leaks can be dangerous for engine life span. Labor cost: High

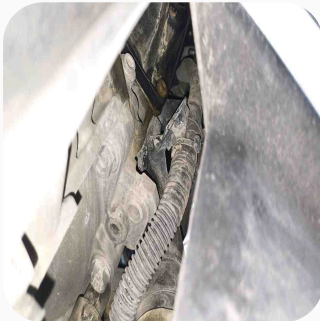
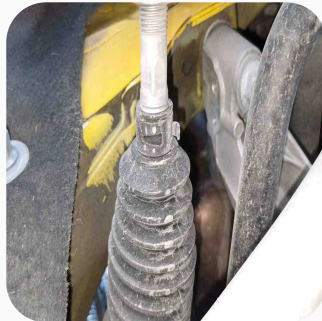
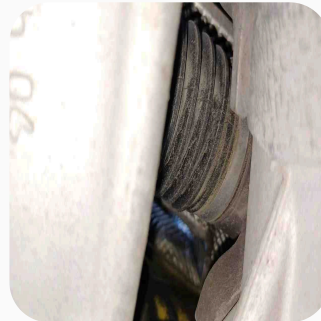
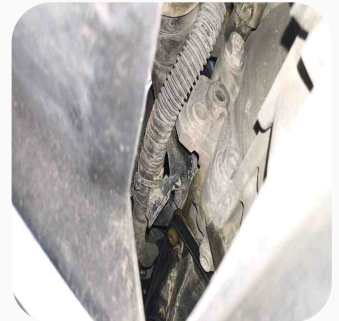
▲ Water scaling/dirt marks

Water scaling/dirt marks in the engine bay- Water scaling or dirt accumulation in the vehicle can indicate exposure to excessive moisture or poor maintenance. This may result from environmental factors such as heavy rainfall or water intrusion. Over time, it can lead to corrosion, electrical issues, or compromised components.

Water scaling/dirt marks on the undercarriage- Water scaling or dirt accumulation in the vehicle can indicate exposure to excessive moisture or poor maintenance. This may result from environmental factors such as heavy rainfall or water intrusion. Over time, it can lead to corrosion, electrical issues, or compromised components.
