# **Vehicle Summary**

Mazda 3
Verified by JerifyBuy

- Date 2025-04-06
- **Time** 5:00 6:00 PM
- Inspection Type
  Comprehensive
- VIN Number

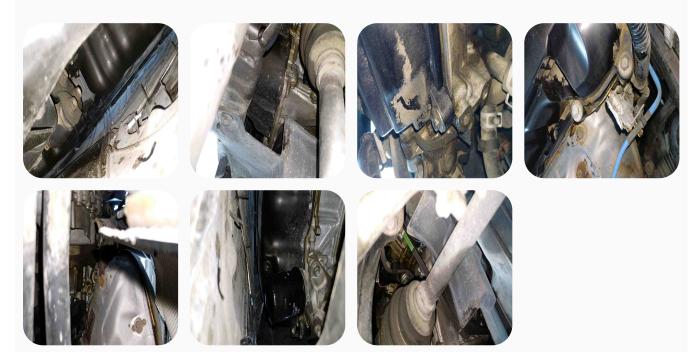
#### **▲** Engine Oil Leaks

**Leak from oil pan gasket -** The oil pan is a reservoir at the bottom of the engine that collects and stores engine oil, which has a leak. This means the seal between the oil pan and the engine is damaged or worn out, causing oil to leak out. Long term oil pan leaks can be dangerous for engine life span. Labor cost: Medium

**Leak from oil pump gasket -** A leak from the oil pump gasket means the seal between the oil pump and the engine block is damaged or worn out, causing oil to leak.Long term oil leaks can be dangerous for engine life span. Labor cost: Medium To High

Leak from valve cover/camshaft gasket- The valve cover gasket is a seal that is placed between the valve cover and the cylinder head of an engine. Its main purpose is to prevent oil leaks from the valve cover. A leak from the valve cover or camshaft gasket means the seal between the valve cover or camshaft cover and the engine is damaged or worn out, causing oil to leak. Long term oil leaks can be dangerous for engine life span. Labor cost: High

**Leak from timing cover gasket -** A leak from the timing cover indicates that the seal around the cover protecting the timing belt or chain is failing, leading to oil leakage. Long term oil leaks can be dangerous for engine life span. Labor cost: High

**Leak from engine rear main seal-** A leak from the engine rear main seal indicates a failure in the seal between the engine and the transmission, allowing oil to escape. If left unaddressed, it can lead to oil depletion and potential engine damage. Labor cost: High
